MISCELLANEOUS PAPER C-78-4

CONCRETE AND ROCK TESTS
REHABILITATION WORK, BRANDON ROAD
DAM, ILLINOIS WATERWAY
CHICAGO DISTRICT

Richard L. Stowe

May 1978

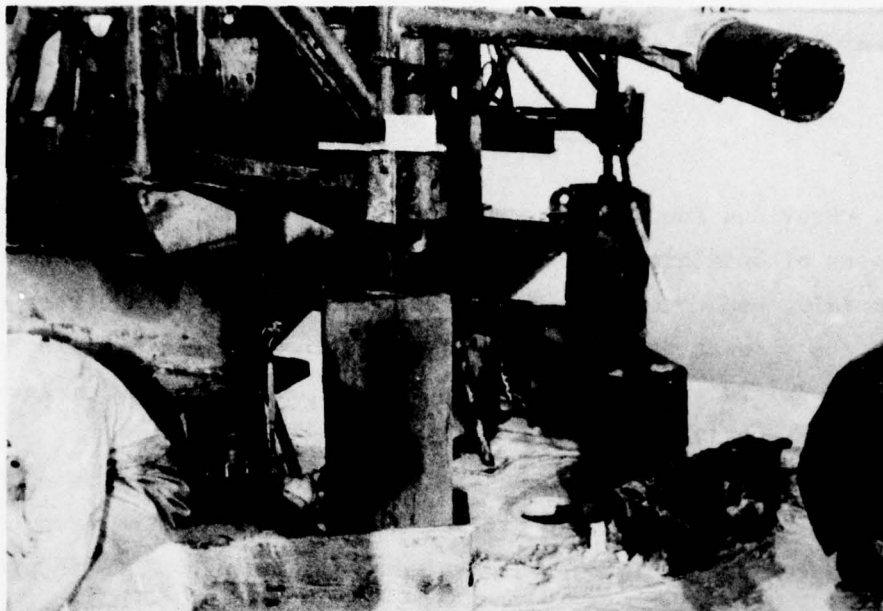
a. Drilling on hole BR WES-1-76, headgate section

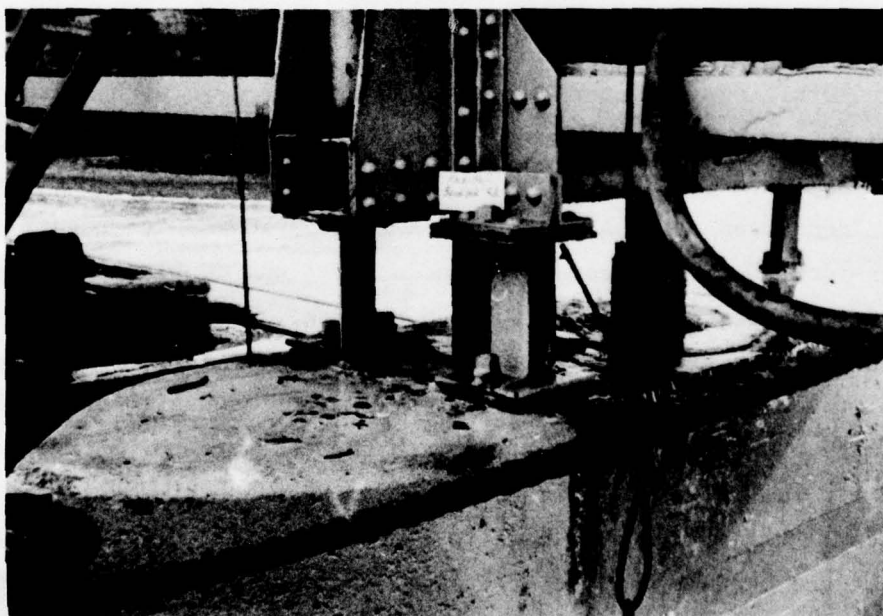
b. Typical drill rig setup over holes BR WES-2 and 3-76, tainter-gate section

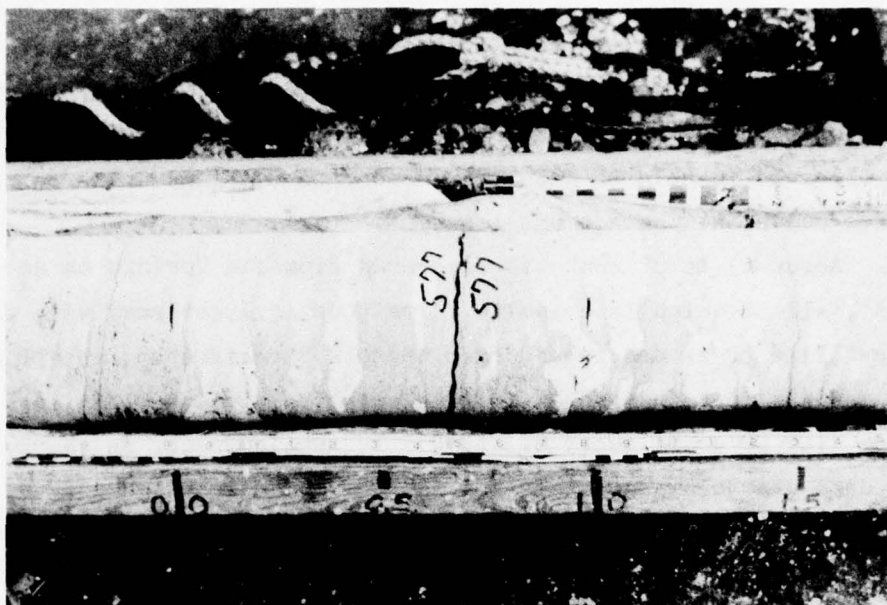
a. Sample of upper rock

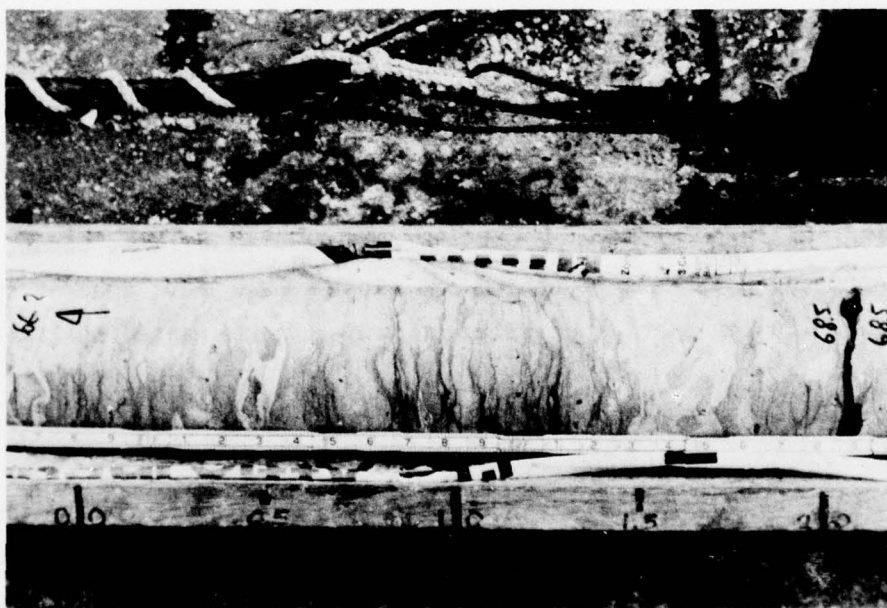
Figure 5. Typical bedrock samples

b. Sample of lower rock showing numerous bedding plains

30. The bedrock is considered competent and massive. No appreciable dip could be measured on the bedding surfaces, therefore bedding is assumed to be horizontal over the foundation. The bedding surfaces are irregular with a nominal 1-in. differential between the peaks and valleys both of which are generally rounded (Figure 5).

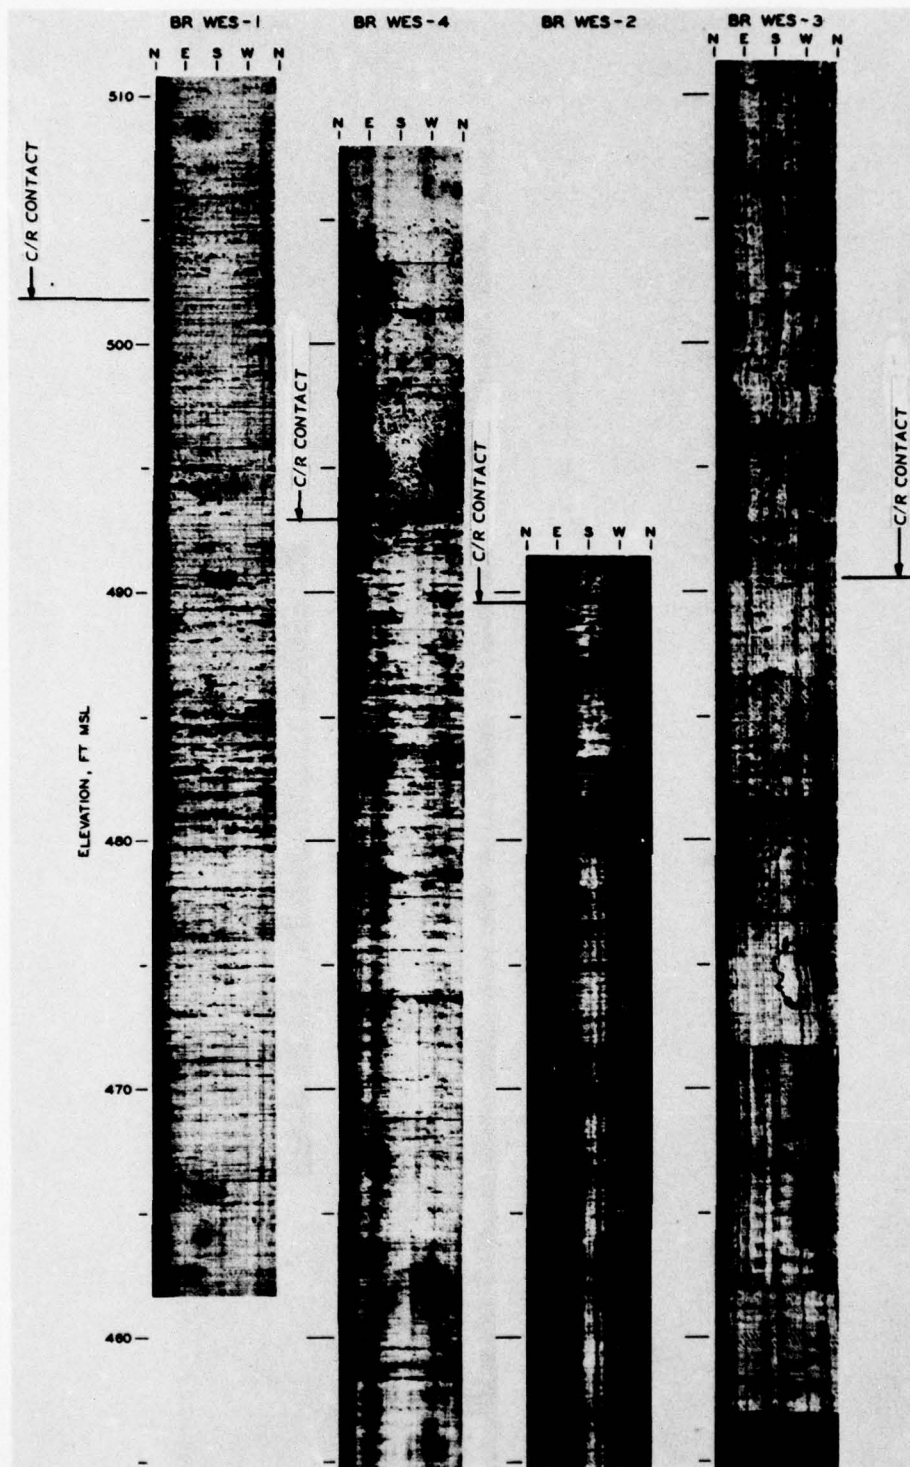
Figure 6. Televiwer logs, section A'-A'

52. Prior to analysis of the televiwer logs, core logs and core photos were consulted with the result that very little geologic structure was indicated in the subsurface to the depths explored in this investigation. The geologic structure considered important for purposes of stability analysis includes joints or bedding planes dipping greater than 10 degrees. Only 15 fractures in rock, most of which were short discontinuous fractures, were described in the core logs of the five borings. Of those 15, only 4 were sufficiently continuous and distinct in the core to be considered joints. These four were also discernible on the televiwer logs and are tabulated below.

<u>Drill Hole No.</u>	<u>El, ft</u>	<u>Strike and Dip</u>
BR WES-1-76	491.0 to 488.8	N 50° E, 75° NW
BR WES-3-76	476.1 to 473.3	N 45° W, Vert.
BR WES-3-76	458.9 to 457.4	N 45° W, Vert.
BR WES-6-76	489.6 to 486.6	N 90° E, 78° S

53. The majority of the other features visible on the televiewer logs are probably horizontal bedding-related structures such as vugs, primarily solution cavities, zones of soft material such as clay and shale that washed out during drilling, and light and dark banding by clay and shale interbeds. The fractures occurring in the boreholes were too scattered to establish the existence of joint sets or set orientations. Deere's rock quality designation¹¹ (RQD) classifies rock as excellent if the RQD is between 90 and 100 percent. On this basis, the rock at Brandon Road would be rated excellent because all breaks in the core were classified as mechanical.
